## **I-195 Washington Bridge (700)**

### **Forensic Evaluation and Procedural Audit Related to PT Tie-Down Failures**

I-195 SB Washington Bridge over Seekonk River  
Providence, RI

April 5, 2024

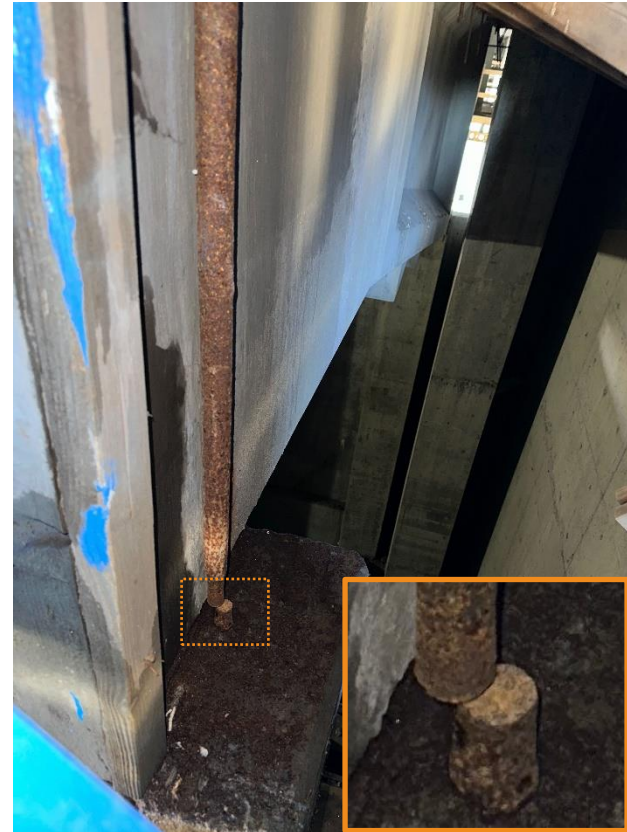
WJE personnel Michael Brown and John Cocca visited the bridge on December 16, 2023. During the site visit the fractured bars and the configuration and condition of the cantilever beams and structural walls at Piers 6 and 7 that the post-tensioned (PT) rods were designed to connect were observed. WJE observed fractured rods at two of four corners of Span 7, at Cantilever A and Cantilever F at Pier 7. At the time, a third rod, Cantilever A at Pier 6, was suspected of also being fractured due to observed movement of the cantilever/rod, but a fracture could not be visibly confirmed. A report noted bouncing of cantilevers and gaps at bearings of adjacent girder lines at the Pier 6 and Pier 7 connections.<sup>1</sup> Photos of the fractured bars taken by WJE on December 16, 2023 are shown in Figures 1 and 2. The bars were corroded on the exterior perimeter and the cross-section was reduced/tapered in the regions around the fractures.

Figure 2. Pier 7 Cantilever F fractured tie-down rod

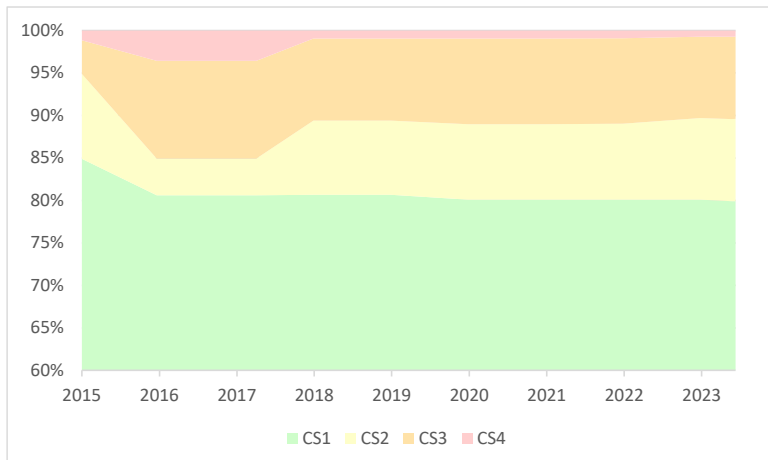
Figure 15. Element 109 Condition State History (2015 to 2023)

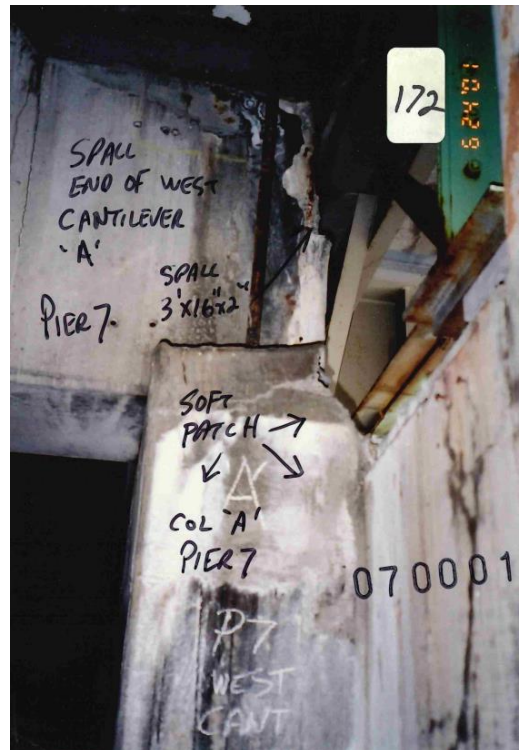
During routine and special inspections, many photos were taken of the external tie-down rods, though these appear to be without exception incidental to documentation of deteriorating conditions of the adjacent reinforced concrete or structural steel elements. In those photos, the progressive corrosion and loss of section, particularly near the upper and lower concrete interfaces, can be captured in a few. For many others, only a small portion of the center section of the bars can be seen, partially obscured by other elements in the foreground. Figures 26 through 36 present photos from inspection reports from 2015 through 2023 that contain the subject exterior tie-down rods in Span 7. The degree of corrosion and section loss are clearly visible in most of these photos. However, note that annotations provided by inspectors do not clearly identify these as post-tensioned high-strength elements. Specifically, annotations in Figures 29 and 30 point directly to the tie-down rods but describe spalls and exposed rebar with section loss.

Figure 26. Inspection photo of exterior tie-down rod for cantilever beam A at Pier 7 taken June 2001 (RIDOT).

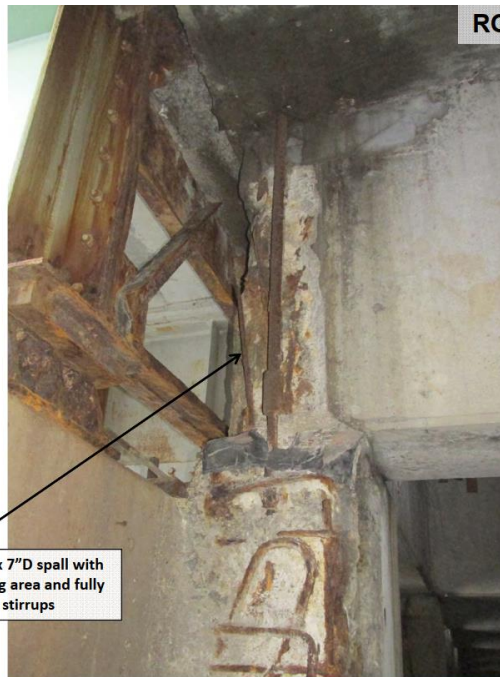
PHOTO #114

FH x 9"W (EF) x 16"W (NF) x 7"D spall with 9"x10"x6"D reduced bearing area and fully exposed and broken stirrups

Span 7 Beam A – N. Face Cant. End at Pier 6  
(LOOKING SOUTH)

Figure 27. Inspection photo of exterior tie-down rod for cantilever beam A at Pier 6 taken July 2015 (AECOM).

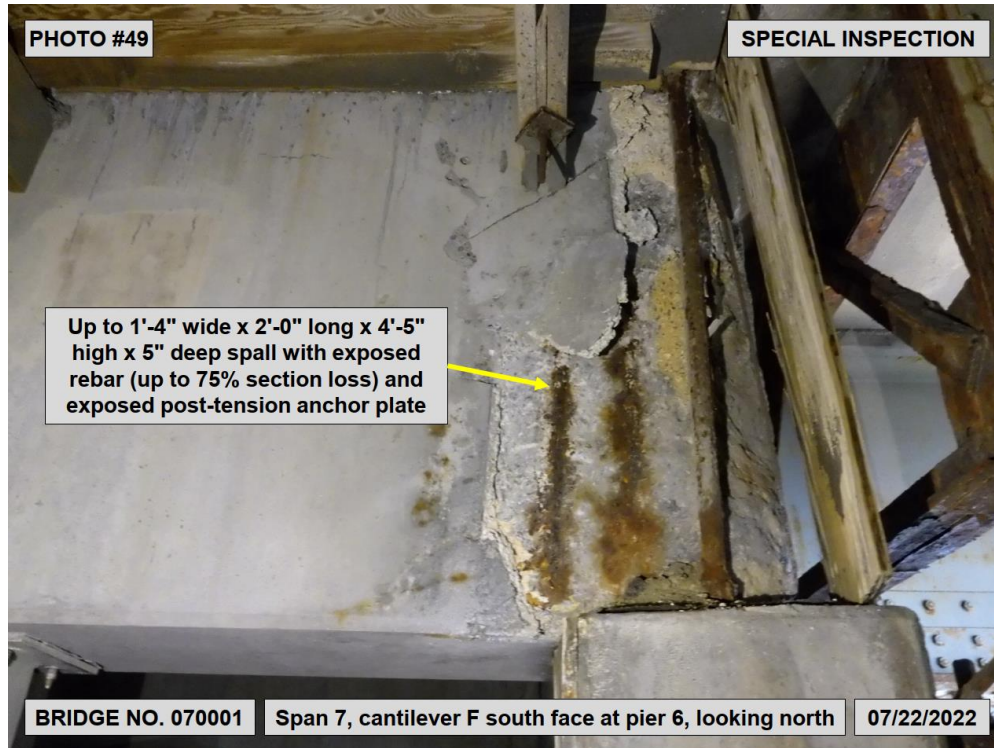
Figure 34. Inspection photo of exterior tie-down rod for cantilever beam F at Pier 6 taken July 2022 (TranSystems).

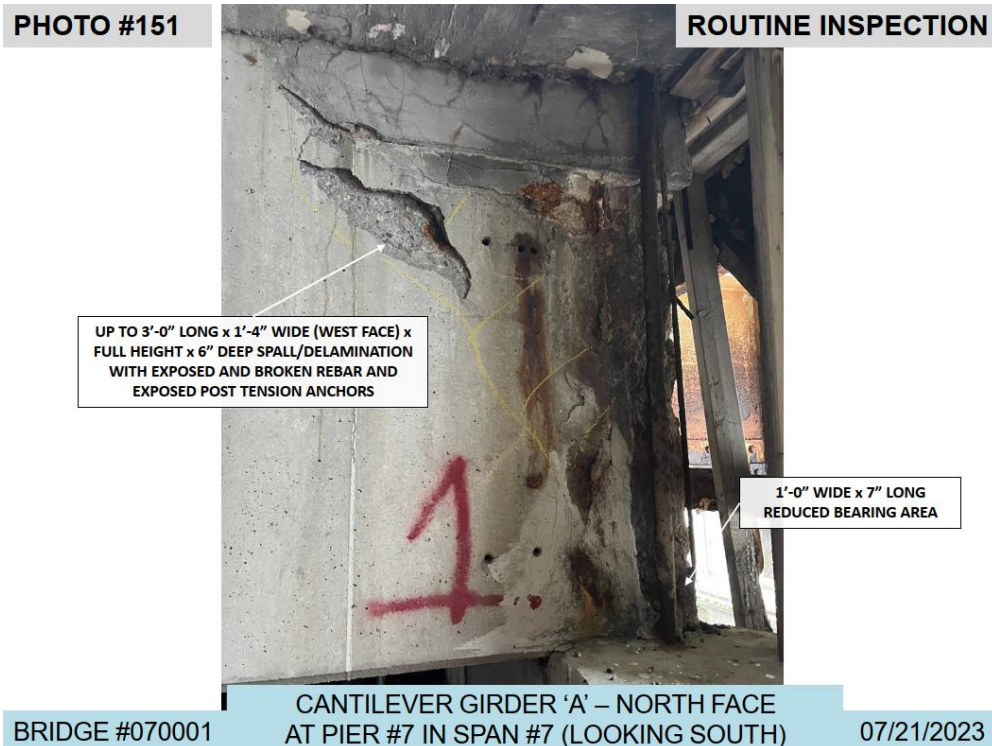
Figure 36. Inspection photo of exterior tie-down rod for cantilever beam A at Pier 7 taken July 2023 (AECOM).
