## **I-195 Washington Bridge (700)**

### **Forensic Evaluation and Procedural Audit Related to PT Tie-Down Failures**

I-195 SB Washington Bridge over Seekonk River  
Providence, RI

April 5, 2024

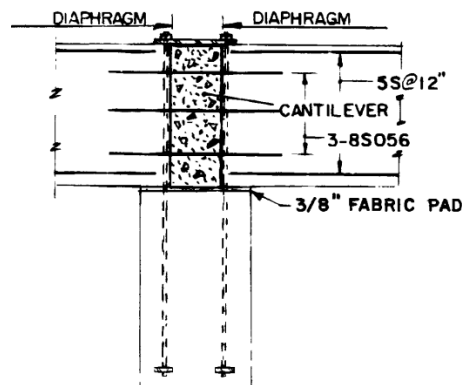
Figure 6. Section depicting PT anchor plates and tie-down rods at end span cantilever supports (Sheet 143, Detail Sheet 8 of original plans, 1967).

At the subject span ends, there are six concrete girder lines (A-F), each with twin tie-down rods connected to an anchor plate at the top that straddles the cantilever beam (Figure 6). The tie-down rods are generally embedded in the diaphragms at ends of the cantilever beams and extend down into the corbels, making them thus not visible for inspection. However, at the four outward corners at girder lines A and F of Piers 6 and 7, the outboard tie-down rods lie to the exterior of the cantilever beam ends, where there are no diaphragms, and are exposed from the top of the beam seat to the bottom of the concrete deck. Original design drawings required the prestressing rods to be  $1 \frac{3}{8}$ " diameter high strength pre-stressing rod with threaded ends (Figures 7 and 8).

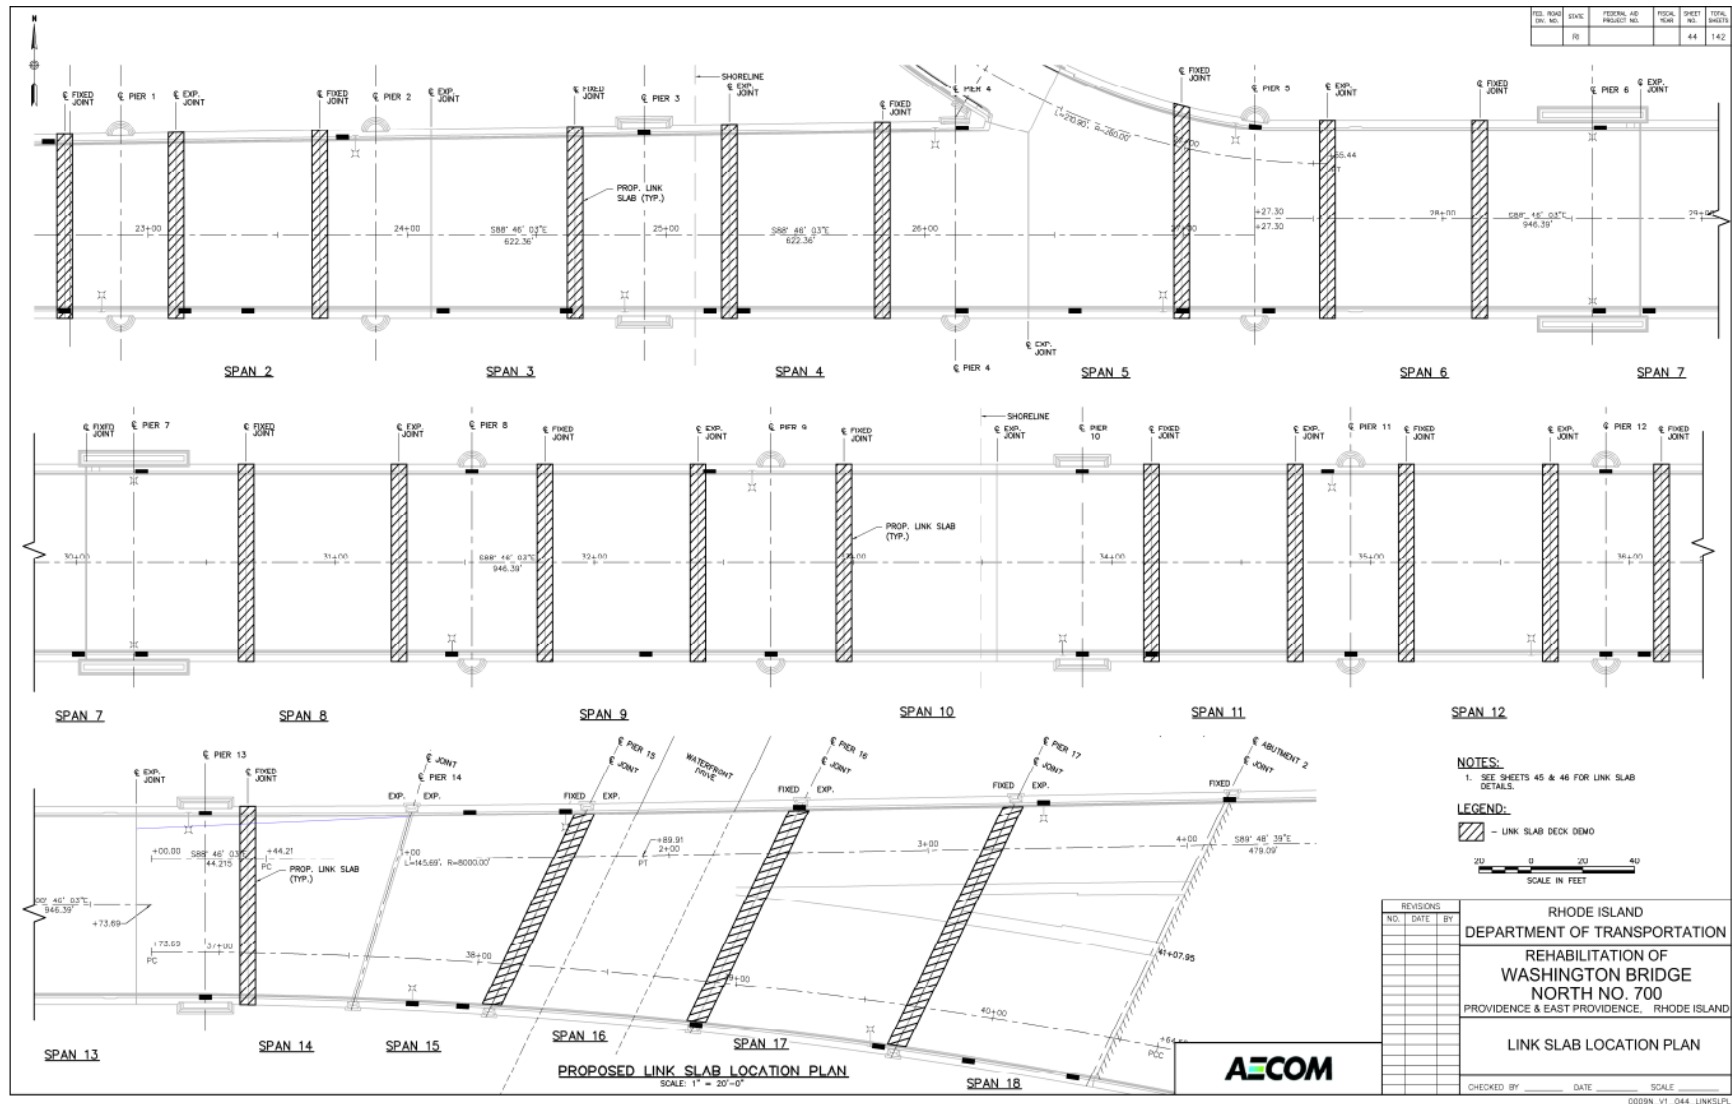
Figure 17. Link slab Location Plan from 2016 Rehabilitation plans, Sheet 44, RIDOT Contract 2016-CB-059, 2016.

Table 3 represents a selective excerpt from the cited Table 7 – 1, showing only the joints where it is proposed that joints remain and accommodate movement of the groups of adjacent spans connected by proposed joint closures. Note that the recommended scenario two to eliminate 23 of 35 joints results in closure of the three joints immediately west of Pier 6 east joint and closure of the 5 joints immediately east of Pier 7 west joint. These closures would result in concentration of thermal movement over segments west of Pier 6 for approximately 236.2 feet of the bridge, and over segments east of the Pier 7 joint over approximately 352.6 feet of the bridge. As a result, based on the values reported by AECOM in its report, movement at Span 7, Pier 6 cantilever was predicted to increase from 1.588 to 3.226, a factor of 2.0 and movement of Span 7, Pier 7 cantilever was predicted to increase from 0.482 to 2.808, a factor of 5.8.

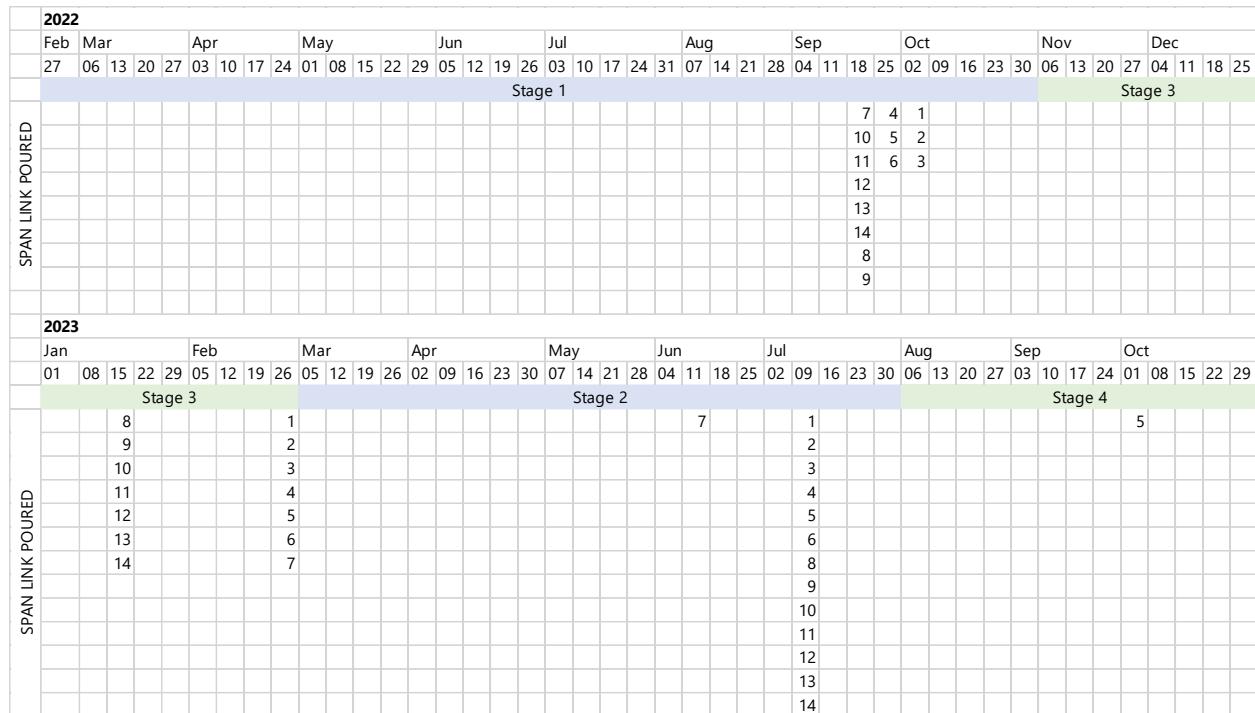
Figure 37. Link slab placement timeline

The two fractured rods were discovered during December 2023. The sequence of link slab closures is illustrated in the timeline of Figure 37. Specifically, closures for Span 6 (adjacent to Pier 6) occurred in September 2022, February 2023, and July 2023. Likewise, Span 7 closures (adjacent to Pier 7), occurred in September 2022, February 2023, and June 2023. The exact time of the fractures cannot be determined, but they were not observed during the July 2023 routine inspection. WJE's forensic evaluation noted that the thickness of corrosion product on the fractured surfaces suggests the fractures had not occurred very close to the time of discovery. However, it is likely fracture occurred within the timeframe that the link slabs were placed.
